Contract #: 04-0120F4Cty: SF/ALA Rte: 80 PM: 13.2/13.9File #: 69.28**WELDING INSPECTION REPORT****Resident Engineer:**Pursell, Gary**Address:** 333 Burma Road**City:** Oakland, CA 94607**Report No:** WIR-013758**Date Inspected:** 04-May-2010**Project Name:** SAS Superstructure**OSM Arrival Time:** 700**Prime Contractor:** American Bridge/Fluor Enterprises, a JV**OSM Departure Time:** 1900**Contractor:** Zhenhua Port Machinery Company, Ltd (ZPMC), Changxing Island **Location:** Shanghai, China

Bridge No: 34-0006**Component:** Tower**Summary of Items Observed:**

WELDING INSPECTION REPORT

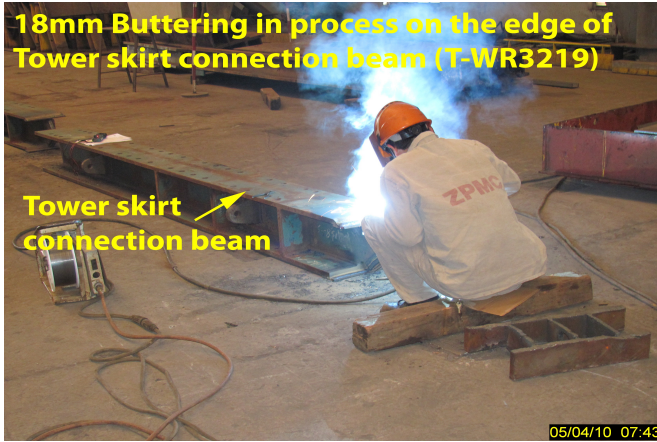
TOWER SKIRT CONNECTION BEAM (T-WR3219)

During random in process verification this QA inspector observed ZPMC personnel performing buttering of about 18mm on the edge of Tower Skirt Connection Beam. Welder is identified as 042218. ZPMC QC is identified as Mr. Shao Hui Long. The welding variables recorded by QC appeared to comply with WPS-345-FCAW-1G(1F)-REPAIR. Attached photograph provides additional details.
